Coal Combustion Waste Impoundment Round 7 - Dam Assessment Report

J.C. Weadock (Site 20)

Fly Ash Dike

Consumers Energy

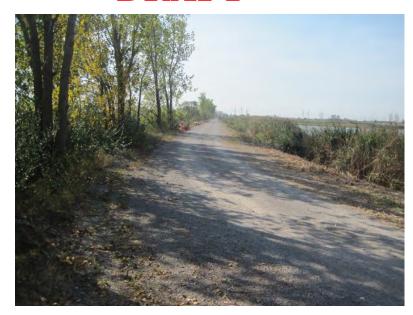
The crest did not show any signs of significant depressions or settlement. A gravel service road covers the entire length of the embankment (see Figures 1 and 2).

Figure 1 - Crest of Section C embankment, Saginaw Bay area on left, Pond F (P3) on right.

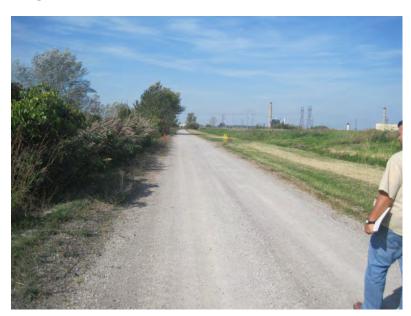
Figure 2 - Crest of Section D embankment, outside slope on left, inside slope on right.

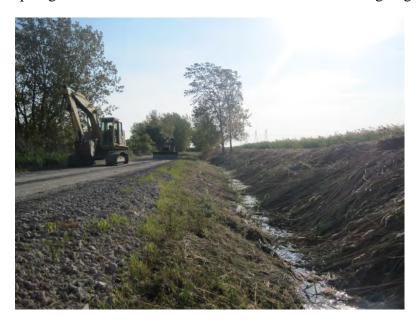
The inside slope is heavily vegetated in areas (see Figures 3 and 4). However, a vegetation management plan is in place, and much of the vegetation was being removed during the site visit. Our site investigation

revealed the presence of a non-native invasive species called "phragmites". There were no obvious indications of sloughing or erosion.

Figure 3 - Evidence of vegetation removal on inside slope on embankment Section A

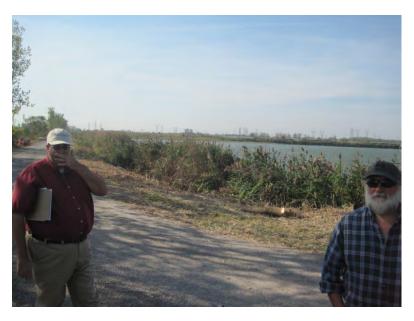
Figure 4 - Evidence of phragmites and other vegetation on inside slope of embankment Section \boldsymbol{C}

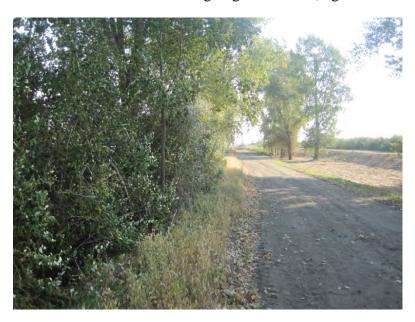
The outside embankment was heavily vegetated and contained several large trees. There was evidence of rip-rap in many locations, but presence

of vegetation and trees made a thorough inspection difficult. There were no obvious indications of sloughing or erosion (Figures 5 and 6).

Figure 5 - Evidence of heavy vegetation and trees on the outside slope of embankment Section A.

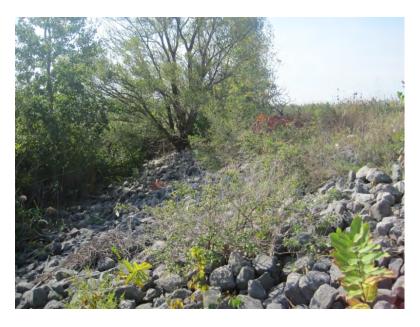
Figure 6 - Rip-rap and large tree and heavy vegetation on outside slope of embankment Section \boldsymbol{C}

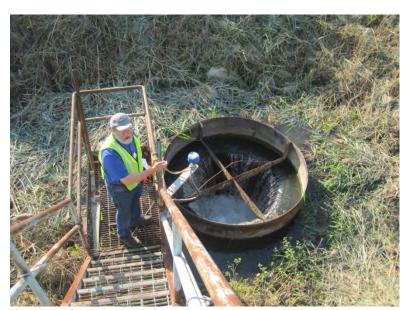
The outlet conduit is a vertical reinforced concrete pipe drop structure connected to a buried horizontal RCP discharge pipe. This vertical riser consists of a 4.5-foot diameter vertical concrete pipe with a larger diameter (8-foot) metal skimmer ring mounted to the top (Figure 7). Water is forced to flow under the metal ring and over the top of the concrete pipe to skim any floating material and prevent clogging. The water level adjacent to the edge of the riser is monitored to measure discharge flow. A horizontal 3-foot-diameter RCP discharges to the channel below the water surface and is submerged and not visible (Figure 8).

Figure 7 - Outlet conduit intake structure

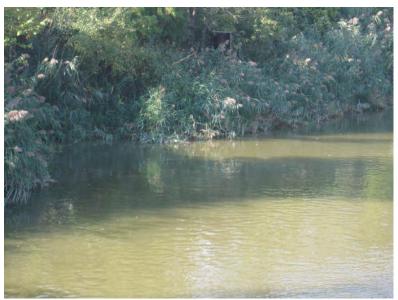
Figure 8 - Area of submerged outlet in discharge channel

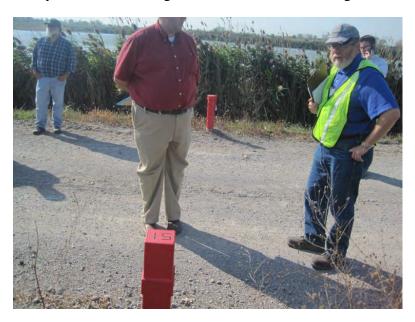
Monitoring wells for measuring water elevation are located on the inside edge of the crest and outside edge of the crest throughout the site (see below). Two monitoring wells are regularly monitored (MW-19 and MW-20). Typical groundwater elevations at these wells are shown in Document 15). There are no survey monuments along the crest to monitor settling.

Figure 9 - Monitoring wells

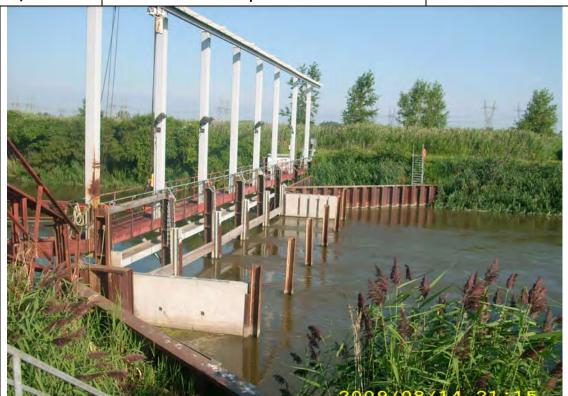
Discharge channel and electric fish barrier showing tall grasses on slope.

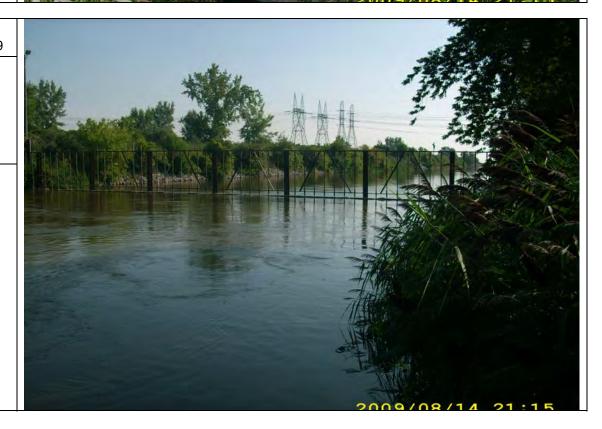
Physical barrier in discharge channel and heavy vegetation on perimeter dike.

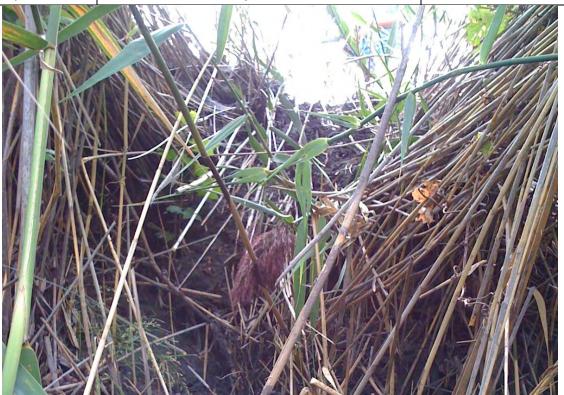
Heavy vegetation and steep slope of perimeter dike along the discharge channel.

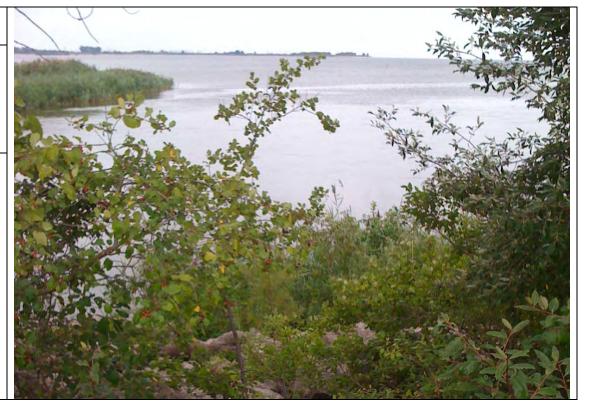
Photo No. 12

Perimeter dike at outlet of discharge channel showing rip rap and heavy vegetation.

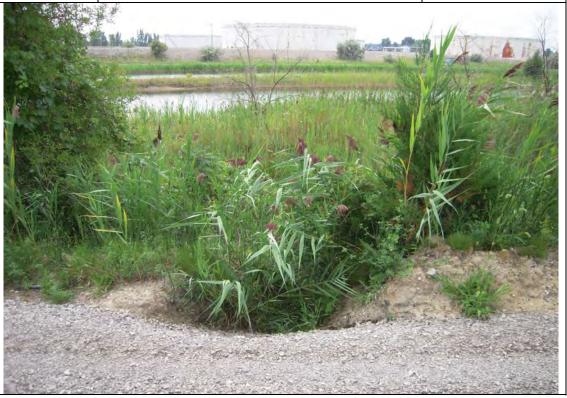
View of fire ponds and remaining erosion from the 2009 overtopping of the perimeter dike.

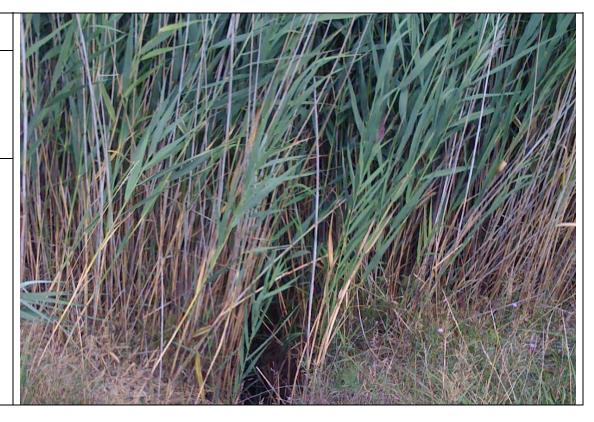
Remaining erosion from 2009 dike overtopping near fire ponds.
